3.1.19.1 SLEEPER LOG/ CHRISTMAS CREEKS UPPER REACHES, RIPARIAN CONDITION

3.1.19.2 SLEEPER LOG/ CHRISTMAS CREEKS, RIPARIAN CONDITION

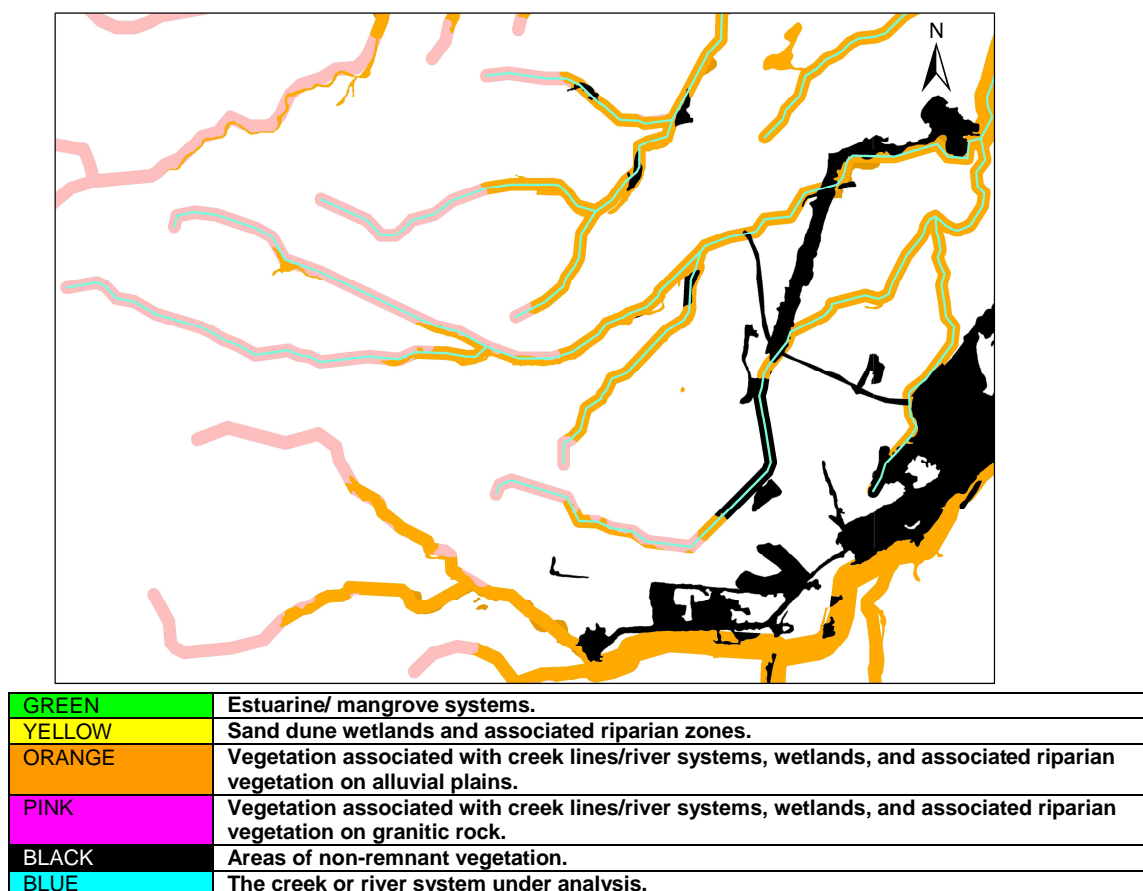
Figure 59: Riparian Systems of Sleeper Log/ Christmas Creeks Upper Reaches

The riparian condition of the upper reaches of Sleeper Log/ Christmas Creeks is moderate. The granitic slopes are in pristine condition with no incursion into the designated buffer zone. Minimal clearing has taken place in the majority of the drainage channels. However, where clearing has occurred, it has been extensive. Clearing in the southern section on the alluvial plains can be attributed to agricultural purposes and possibly for construction of a World War 2 airstrip.

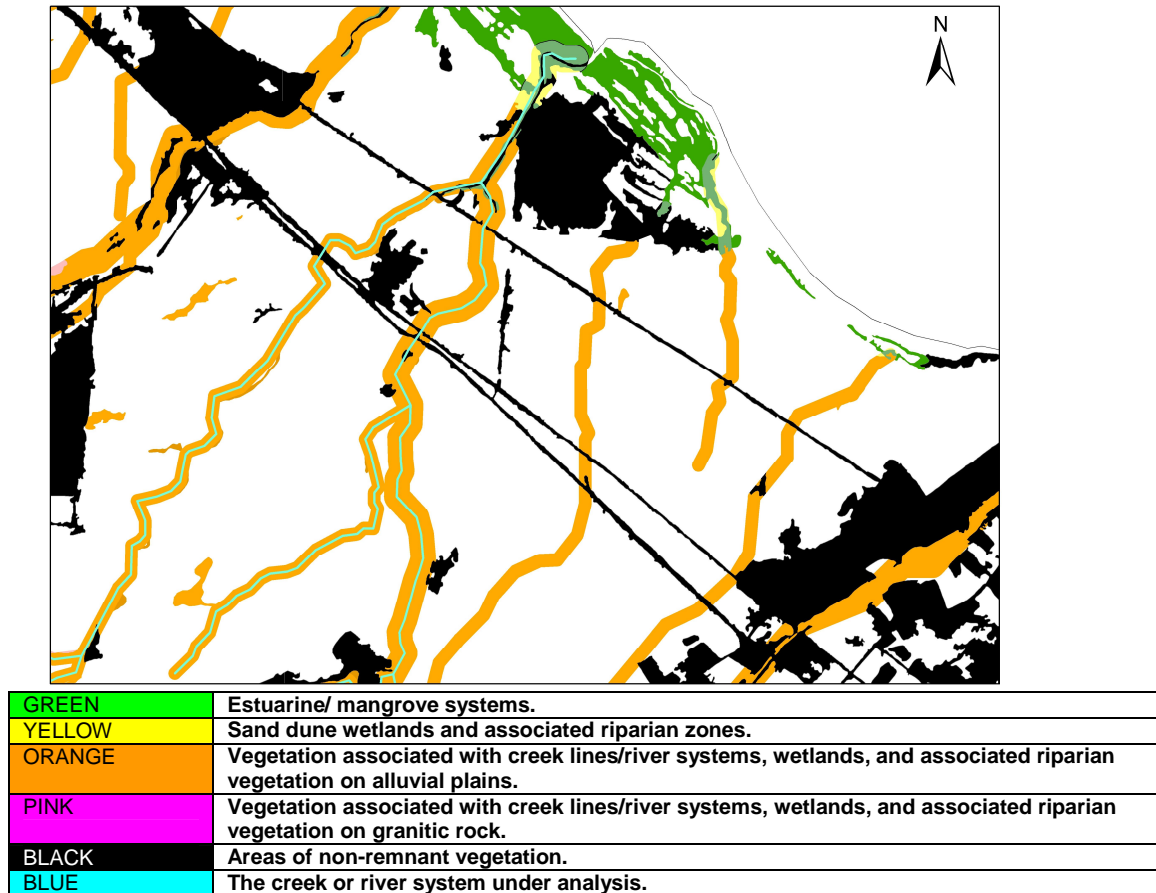
Figure 60: Riparian Systems of Sleeper Log/ Christmas Creeks Lower Reaches

The lower reaches of the Sleeper Log/ Christmas Creeks system are in moderate to good condition with minimal incursion into designated buffer zones. Breaches within the designated buffer zones include road and rail corridors and some minor clearing for agriculture and other purposes. Creeks that traverse these areas have no riparian coverage with water traveling over non-vegetated surfaces. These cleared areas could compromise water quality. However, apart from these minor incursions, there is no major compromise of the designated buffer zone

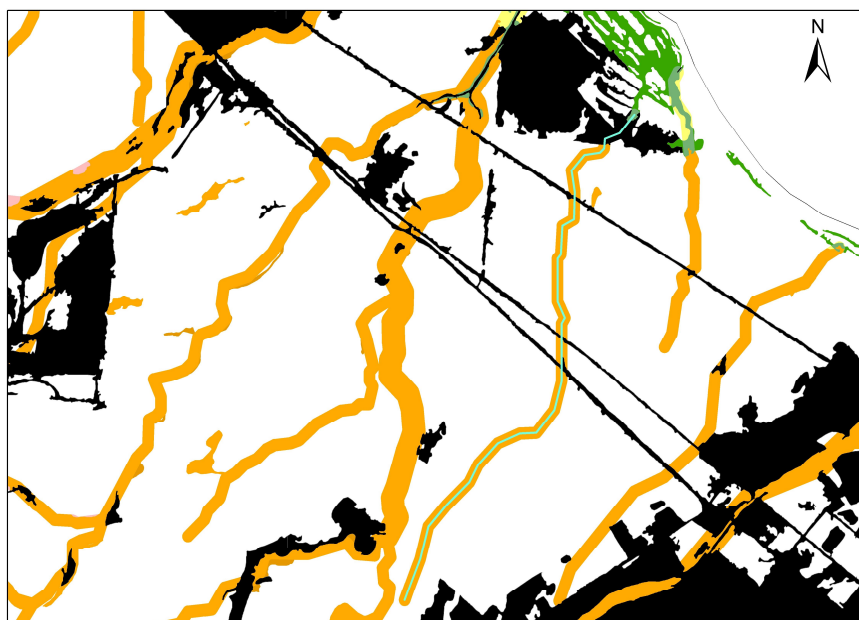
Figure 62: Riparian Systems of Two Mile Creek

The riparian system of Two Mile Creek is in good condition with minimal incursion into the designated buffer zone. The only breaches of the designated buffer zone are road and rail corridors, with some minor clearing for aquaculture purposes in the estuarine sand dune zone. Apart from these minor incursions there is very little compromise of the designated buffer zone

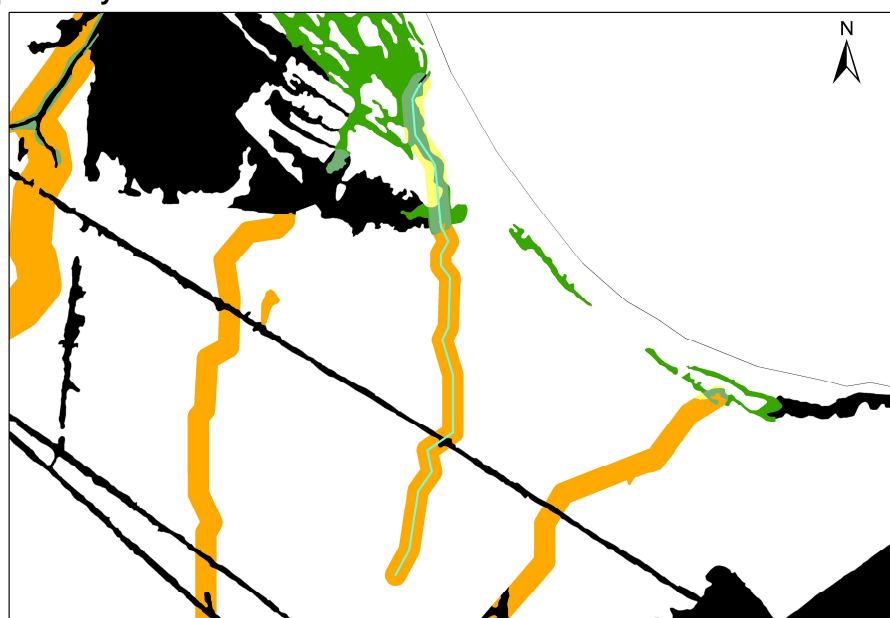
Figure 64: Riparian Systems of Creek 7

Creek 7 has pristine riparian vegetation. The only breach within the designated buffer zone is the railway corridor.

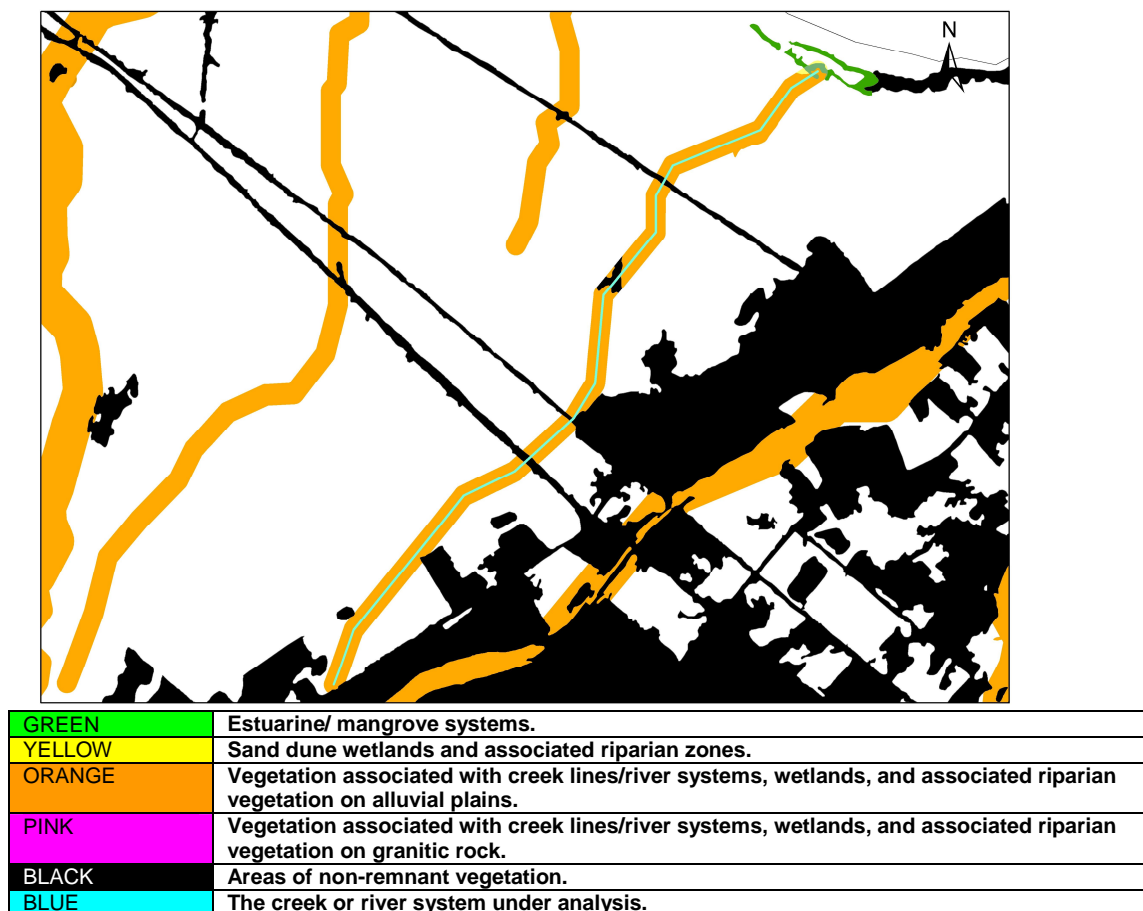
Figure 66: Riparian Systems of Creek 8

Creek 8 has good riparian condition with minimal incursion into the designated buffer zone. The only breach of the designated buffer zone is for road and rail corridors. Apart from these minor incursions there is little compromise of the designated buffer zone

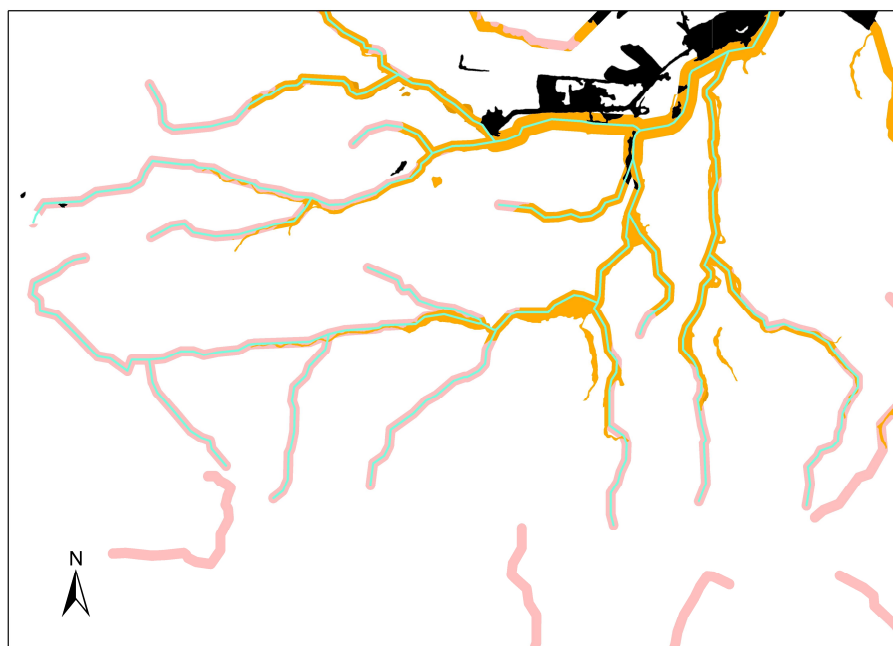
Figure 69: Riparian Systems of Bluewater Creek Upper Reaches

The riparian system of the upper reaches of Bluewater Creek is in good condition. On the upper granitic slopes there is no incursion into the designated buffer zone and only minimal disturbance at the base of the scarp with some minor encroachments into the riparian vegetation. These disturbances are for small agricultural farms and access tracks. Apart from these minor incursions there is no breach of the designated buffer system.

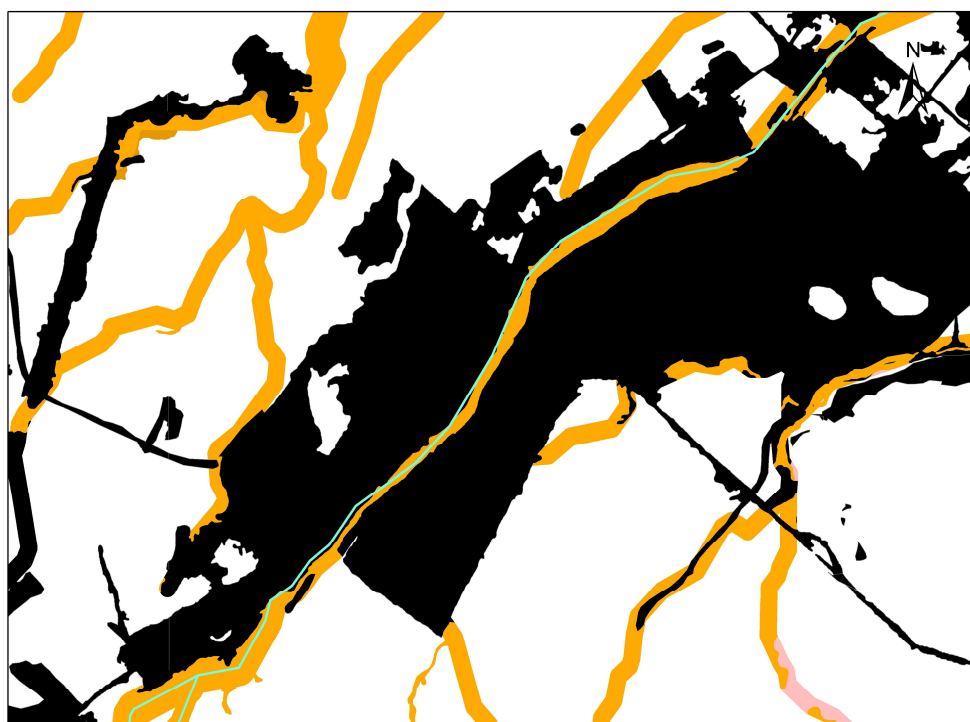
Figure 70: Riparian Systems of Bluewater Creek Middle Reaches

The middle reaches of Bluewater Creek have a poor riparian condition. This reach is highly modified with major breaches into the designated buffer zone. This poor condition is mainly due to residential development along the northern bank and pastoral usage along the southern bank. Compromises to water quality are likely from this area from a combination of overland flow in combination with the dispersive and erosive soils of the adjacent area.

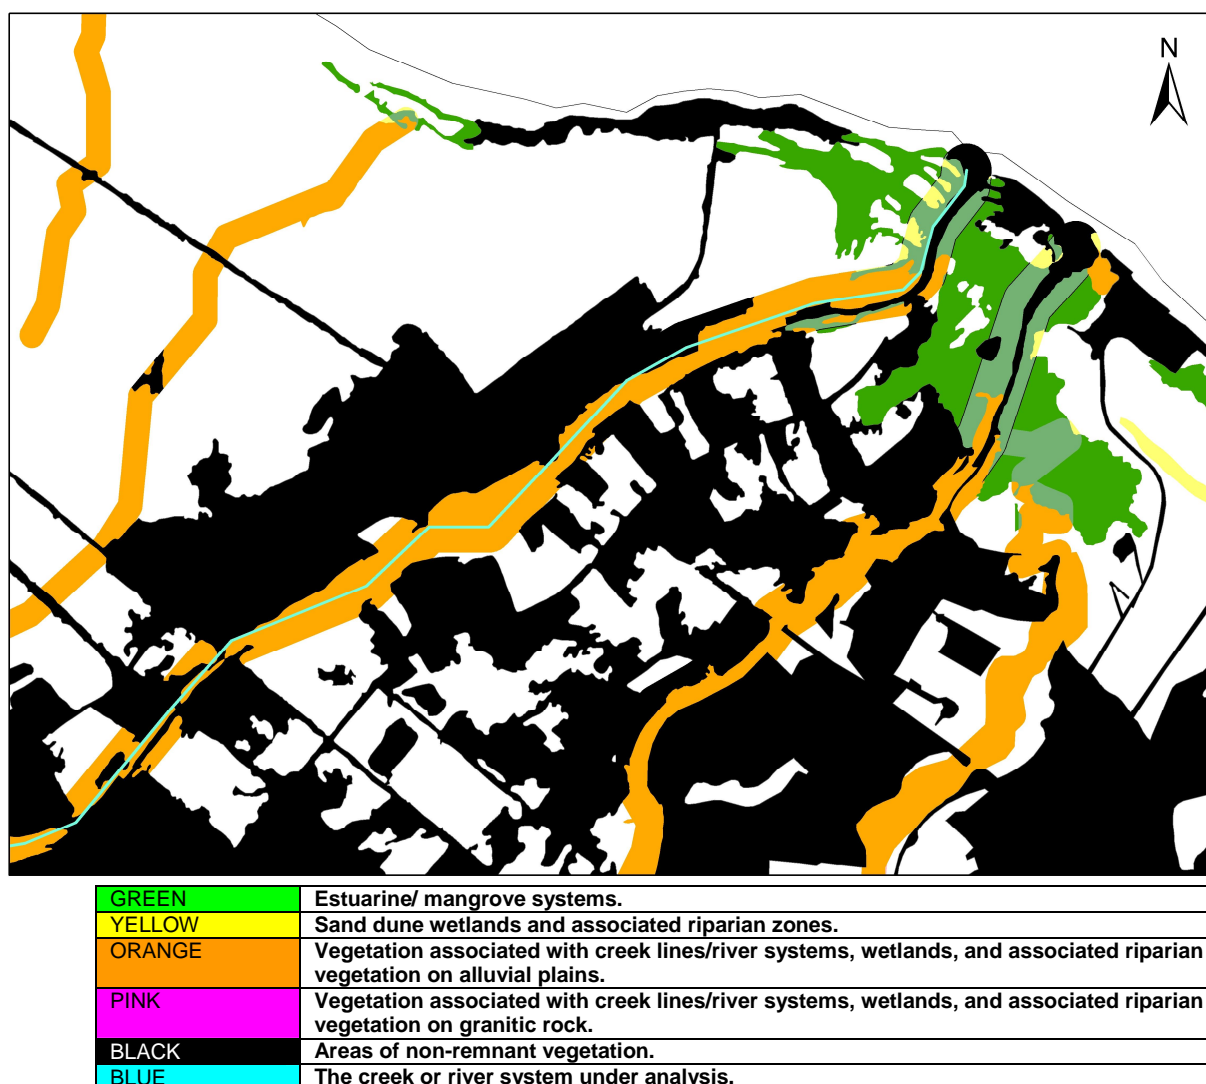
Figure 71: Riparian Systems of Bluewater Creek Lower Reaches

The riparian condition of the Lower Reaches of Bluewater Creek is moderate. Significant areas adjacent to 3rd and 4th order streams have been cleared within the designated buffer zone, although little of this clearing is directly adjacent to the channel. The majority of the clearing within this zone has been for rural residential purpose. Previous usage was pastoral, with some grazing still being undertaken. While there is a possibility of overland flow resulting in compromised water quality, this is more likely to emanate from the middle reaches of the creek.

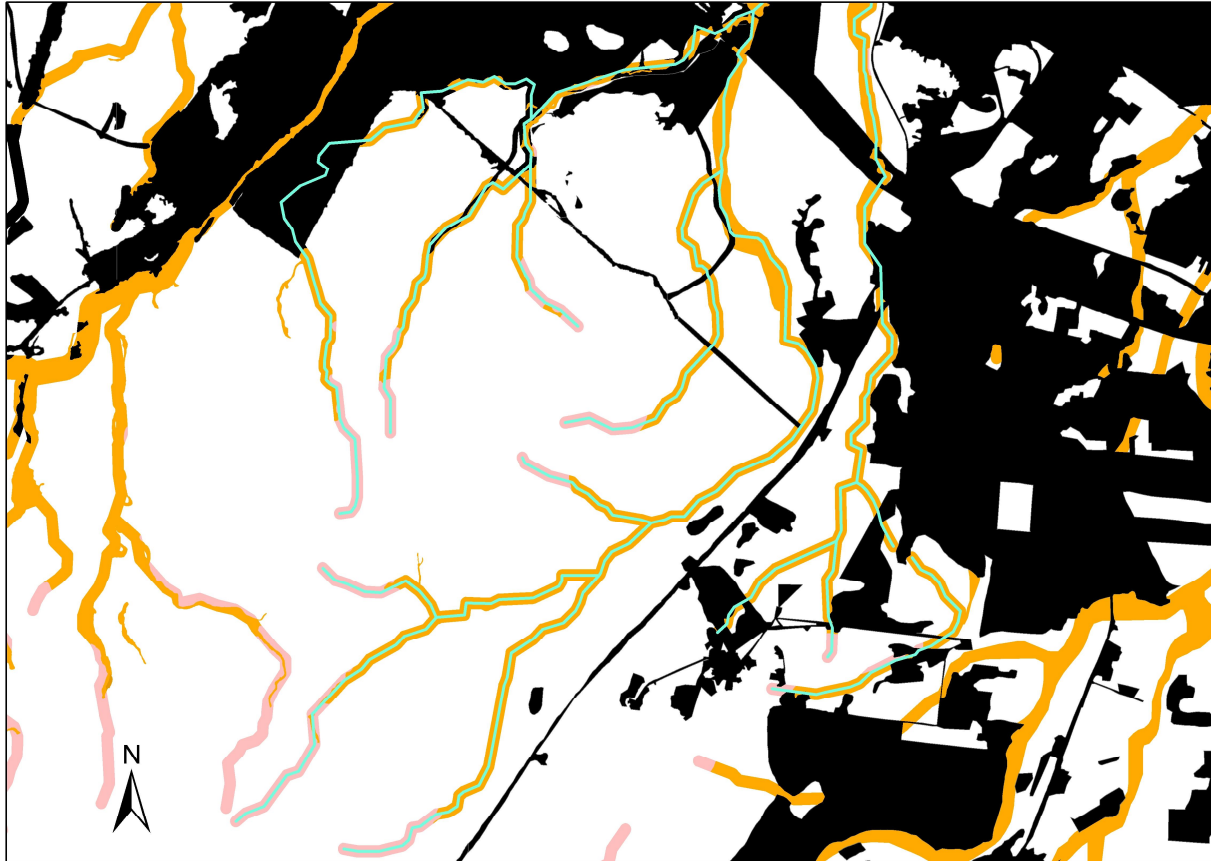
Figure 74: Riparian Systems of Deep / Althaus / Healy Creeks, Upper Reaches

The upper reaches of Deep / Althaus / Healy Creeks have a moderate riparian condition. Several 1st and 2nd order streams have little to no riparian vegetation within the designated buffer zone. The majority of clearing within this reach has been for cattle grazing. Where clearing has occurred it has been to the high bank. These cleared areas are on sodic and erodible soils which may result in compromises to water quality.

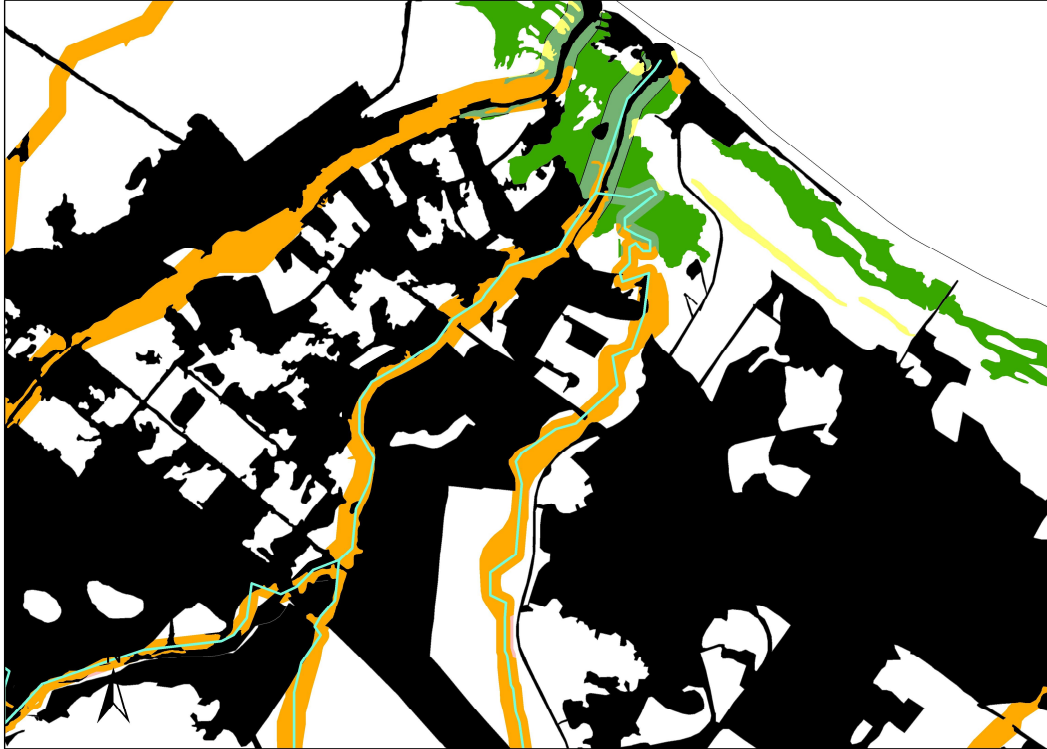
Figure 75: Riparian Systems of Deep/ Althaus /Healy Creek Lower Reaches

The riparian condition of the lower reaches of the Deep/ Althaus/ Healy Creek system is poor/moderate. Significant areas adjacent to 3rd and 4th order streams have been cleared within the designated buffer zone. However, little of this clearing is directly adjacent to the channel. The majority of the clearing within this zone has been for rural residential purposes. Previous usage was pastoral and some grazing is still being undertaken in the region. There is a possibility of overland flow compromising water quality, although this is more likely to occur in the middle reaches rather than the lower reaches.

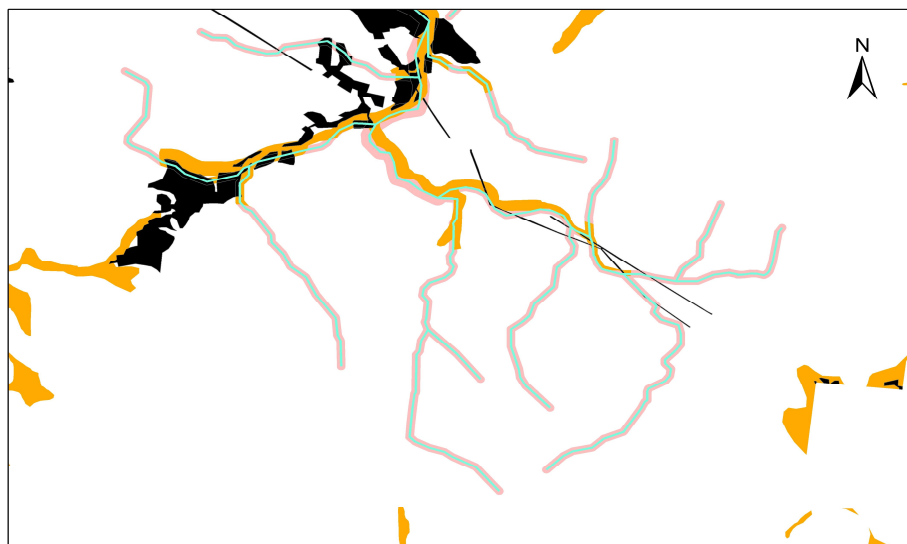
Figure 79: Riparian Systems of Alligator Creek Upper Reaches

The riparian condition of the upper reaches of Alligator Creek is moderate conditions. All the areas within the Bowling Green Bay National Park are in pristine condition with only minimal incursion into the designated buffer zone. Riparian condition is compromised in the western anabranches with an unconfirmed land use and cattle grazing taking place within this part of the catchment. However these land use are not extensive throughout this reach.

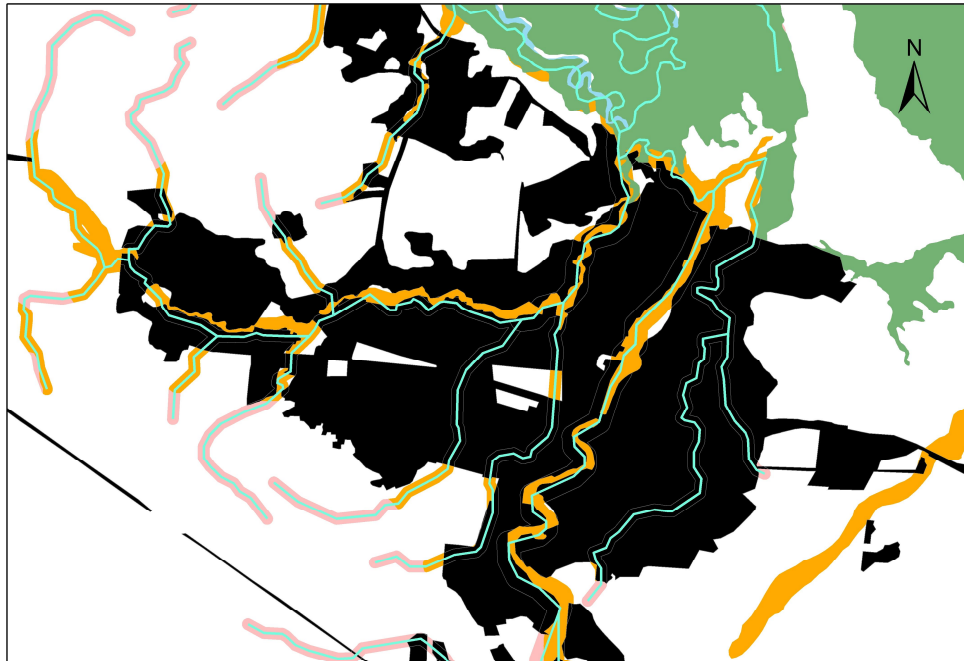
Figure 80: Riparian System of Alligator Creek Middle Reaches

The middle reaches of Alligator Creek are in poor condition. Clearing for grazing and rural residential purposes has resulted in little to no natural riparian vegetation along large areas in both 1st/2nd order streams, and 3rd/4th order streams. This combined with moderately sodic soils and the resulting likelihood of overland flows on gentle undulating slopes could result in a compromise in water quality. The expansion of rural residential development and future reliance on groundwater could further degrade the riparian condition with in the hyporheic zones associated with streams within this area.

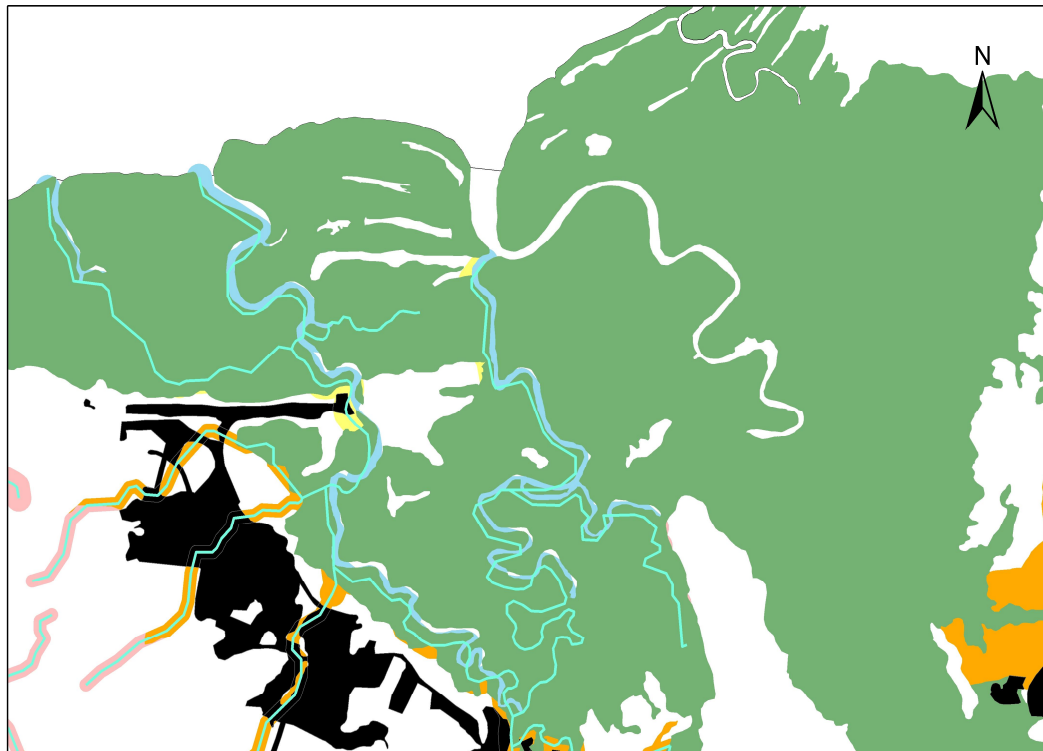
Figure 81: Riparian System of Alligator Creek Lower Reaches

The lower estuarine reaches of Alligator Creek are in good condition. The majority of the reach is bordered by mangroves grading to sparsely vegetated estuarine salt flats. This is the natural condition of these estuarine areas. Minimal clearing and modification has taken place in this area and vast expanses of marine vegetation adjoining Alligator, Crocodile, Coco and numerous other unnamed creeks.
