3.1.19.1 SLEEPER LOG/ CHRISTMAS CREEKS UPPER REACHES, RIPARIAN CONDITION

3.1.19.2 SLEEPER LOG/ CHRISTMAS CREEKS, RIPARIAN CONDITION

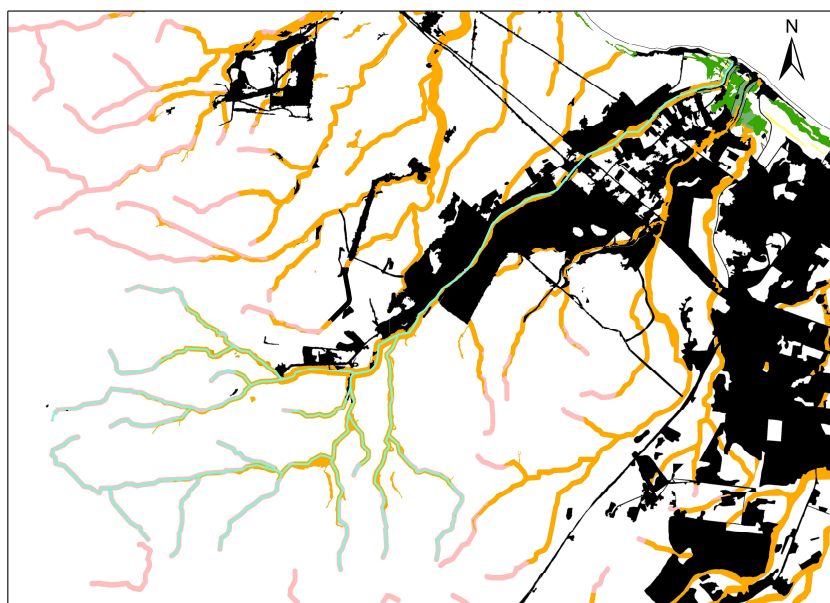
Figure 68: Riparian Systems of Bluewater Creek

The riparian system of the upper reaches of Bluewater Creek is in good condition. On the upper granitic slopes there is no incursion into the designated buffer zone and only minimal disturbance at the base of the scarp with some minor encroachments into the riparian vegetation. These disturbances are for small agricultural farms and access tracks. Apart from these minor incursions there is no breach of the designated buffer system.

The middle reaches of Bluewater Creek have a poor riparian condition. This reach is highly modified with major breaches into the designated buffer zone. This poor condition is mainly due to residential development along the northern bank and pastoral usage along the southern bank. Compromises to water quality are likely from this area from a combination of overland flow in combination with the dispersive and erosive soils of the adjacent area.

The riparian condition of the Lower Reaches of Bluewater Creek is moderate. Significant areas adjacent to 3rd and 4th order streams have been cleared within the designated buffer zone, although little of this clearing is directly adjacent to the channel. The majority of the clearing within this zone has been for rural residential purpose. Previous usage was pastoral, with some grazing still being undertaken. While there is a possibility of overland flow resulting in compromised water quality, this is more likely to emanate from the middle reaches of the creek.

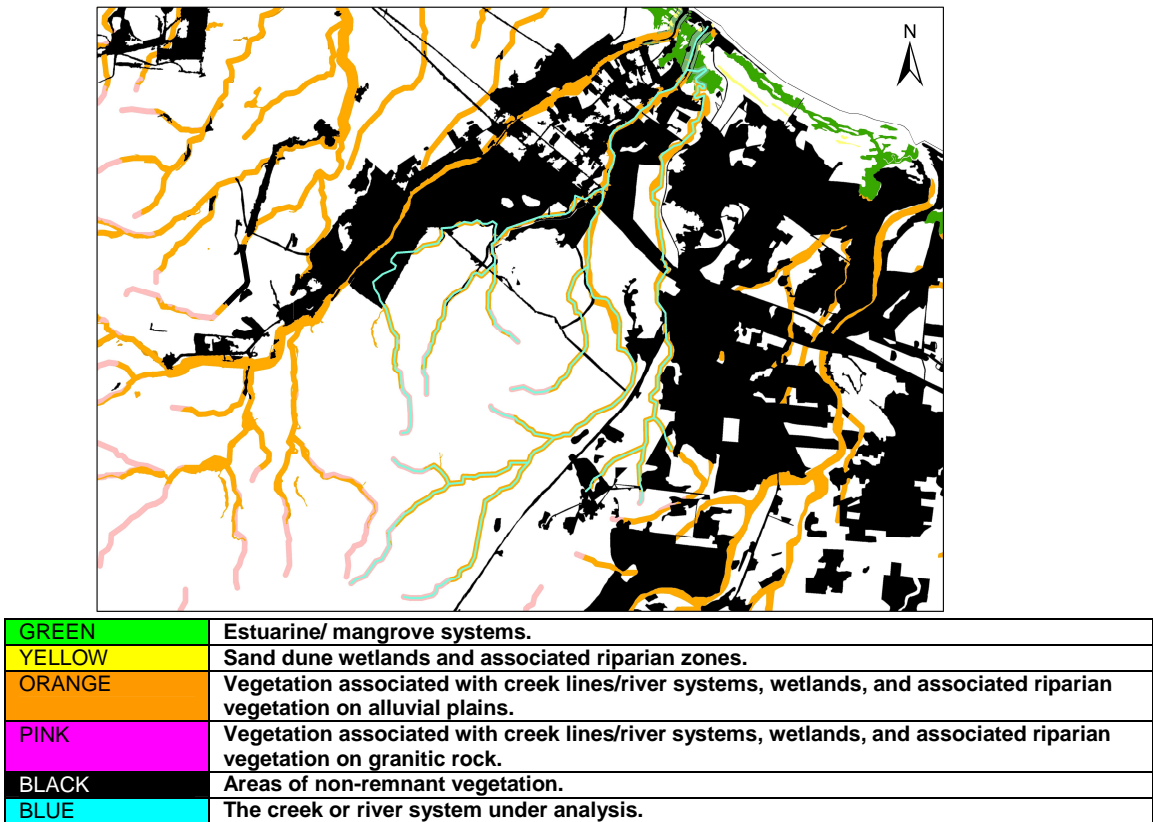
Figure 73: Riparian Systems of Deep/ Althaus / Healy Creeks

The upper reaches of Deep / Althaus / Healy Creeks have a moderate riparian condition. Several 1st and 2nd order streams have little to no riparian vegetation within the designated buffer zone. The majority of clearing within this reach has been for cattle grazing. Where clearing has occurred it has been to the high bank. These cleared areas are on sodic and erodible soils which may result in compromises to water quality.

The riparian condition of the lower reaches of the Deep/ Althaus/ Healy Creek system is poor/moderate. Significant areas adjacent to 3rd and 4th order streams have been cleared within the designated buffer zone. However, little of this clearing is directly adjacent to the channel. The majority of the clearing within this zone has been for rural residential purposes. Previous usage was pastoral and some grazing is still being undertaken in the region. There is a possibility of overland flow compromising water quality, although this is more likely to occur in the middle reaches rather than the lower reaches.

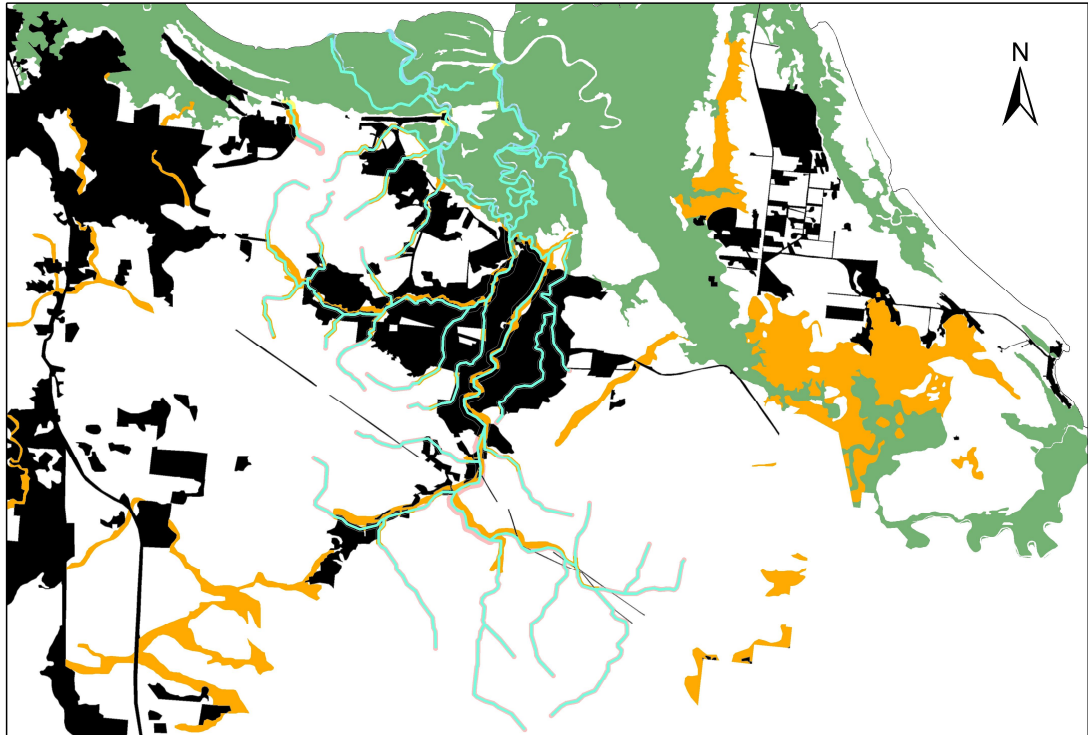
Figure 78: Riparian Systems of the Alligator Creek Catchment

The riparian condition of the upper reaches of Alligator Creek is moderate conditions. All the areas within the Bowling Green Bay National Park are in pristine condition with only minimal incursion into the designated buffer zone. Riparian condition is compromised in the western anabranches with an unconfirmed land use and cattle grazing taking place within this part of the catchment. However these land use are not extensive throughout this reach.

The middle reaches of Alligator Creek are in poor condition. Clearing for grazing and rural residential purposes has resulted in little to no natural riparian vegetation along large areas in both 1st/2nd order streams, and 3rd/4th order streams. This combined with moderately sodic soils and the resulting likelihood of overland flows on gentle undulating slopes could result in a compromise in water quality. The expansion of rural residential development and future reliance on groundwater could further degrade the riparian condition with in the hyporheic zones associated with streams within this area.

The lower estuarine reaches of Alligator Creek are in good condition. The majority of the reach is bordered by mangroves grading to sparsely vegetated estuarine salt flats. This is the natural condition of these estuarine areas. Minimal clearing and modification has taken place in this area and vast expanses of marine vegetation adjoining Alligator, Crocodile, Coco and numerous other unnamed creeks.
